SUBJECT: SIDE SCAN SONAR AND DIVER INVESTIGATION SURVEYS AT THE RARITAN BAY SLAG SITE, SITE INVESTIGATION AND ANALYTICAL RESULTS - WORK ASSIGNMENT #0-356

SITE INVESTIGATION

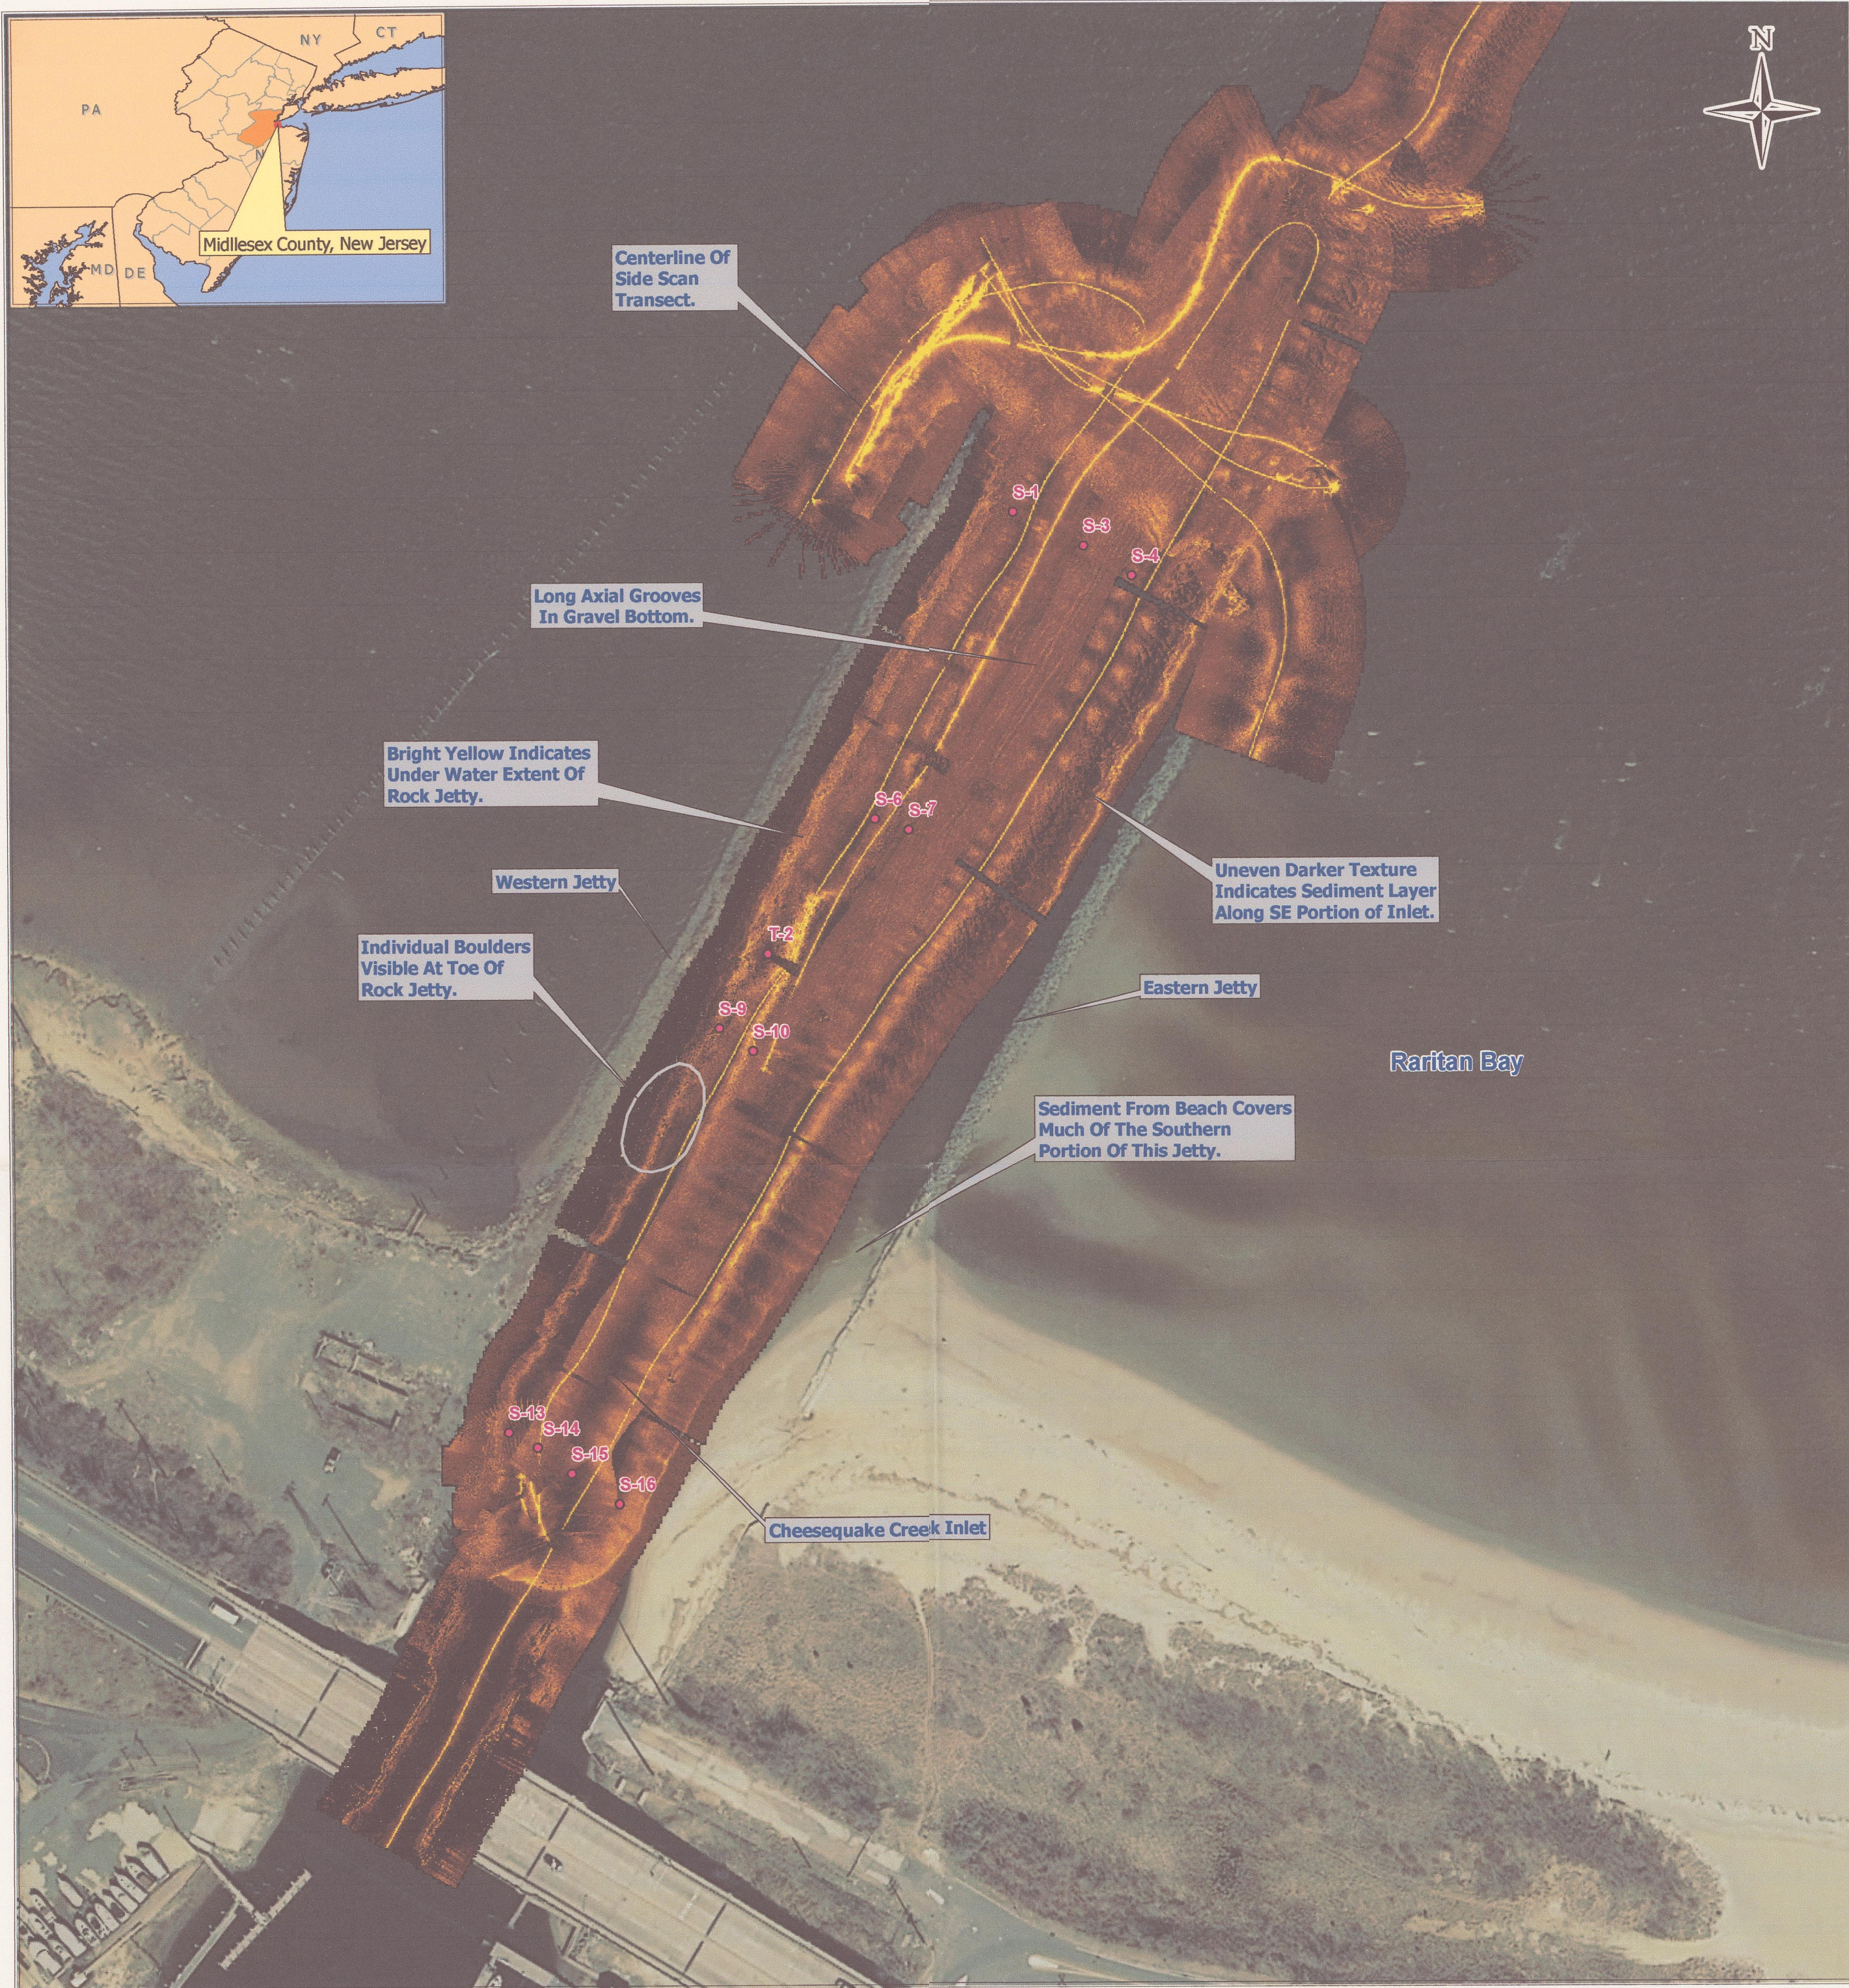
Figure 1
Side Scan Imagery Cheesquake Creek Inlet
Raritan Bay Slag Site
Old Bridge Township, New Jersey
May, 2009

The side scan imagery was post processed and a mosaic was created to cover the inlet and the neighboring jetties (See Figure 1). The sediment sample locations were plotted based on global positioning system (GPS) coordinates and added to the sonar mosaic.

2. The main channel of the Cheesequake Creek Inlet is of a uniform material with long axial grooves. Diver reconnaissance agreed with the sonar picture and further clarified that the material was rounded gravel approximately 1 to 2 inches in size. The grooves were "v" shaped, approximately one foot in width and ran axially along the inlet. Minimal sediment was found in these areas. The main channel composition was homogenous up to the Western Jetty.

3. To the southeast of the gravel channel, a darker area with uneven texture can be seen on the sonar mosaic. This area contains a sandy material, and the uneven structures seen on the sonar mosaic are sand waves created by the changing currents in the inlet. Divers were unable to positively verify this composition; however, during a transect that began at S-6 and finished at S-7, a changeover was noted from the gravel bottom to a much more sandy bottom, indicating that the southwestern area is most likely sand covered. The aerial photograph shown on Figure 1 seems to indicate that the beach located to the southeast has been depositing sand onto and over the Eastern Jetty.

4. Sonar records indicated a large boulder in the location noted T-2. This location was verified by the diver as a large boulder located at the toe of the rock jetty.

5. Divers observed that the boulders at the toe of the slope were large, angular quarry stone covered in algae and many orange sponges. Slag was not observed by the divers along the toe of the Western jetty on the inlet side.

Four of the 11 samples (S-9, S-13, S-14 and S-16) contained sediment that was analyzed for target analyte list (TAL) metals plus tin (Sn). Table 1 summarizes the analytical results. Appendix A provides the Final Analytical Report. Sample S-9 collected at the toe of the Western Jetty (See Figure 1) had particularly high concentrations of antimony (Sb), arsenic (As), copper (Cu), iron (Fe), lead (Pb) and zinc (Zn).

Two areas have not been fully investigated: the area to the west of the western jetty, and the inlet side of the eastern jetty. Based on the results of the side scan sonar survey and the dive operations, the inlet side of the eastern jetty should contain much more sedimentary material than the western jetty. This material was not adequately sampled during this investigation. Also, the area to the outside of the western jetty was not sampled during this investigation.

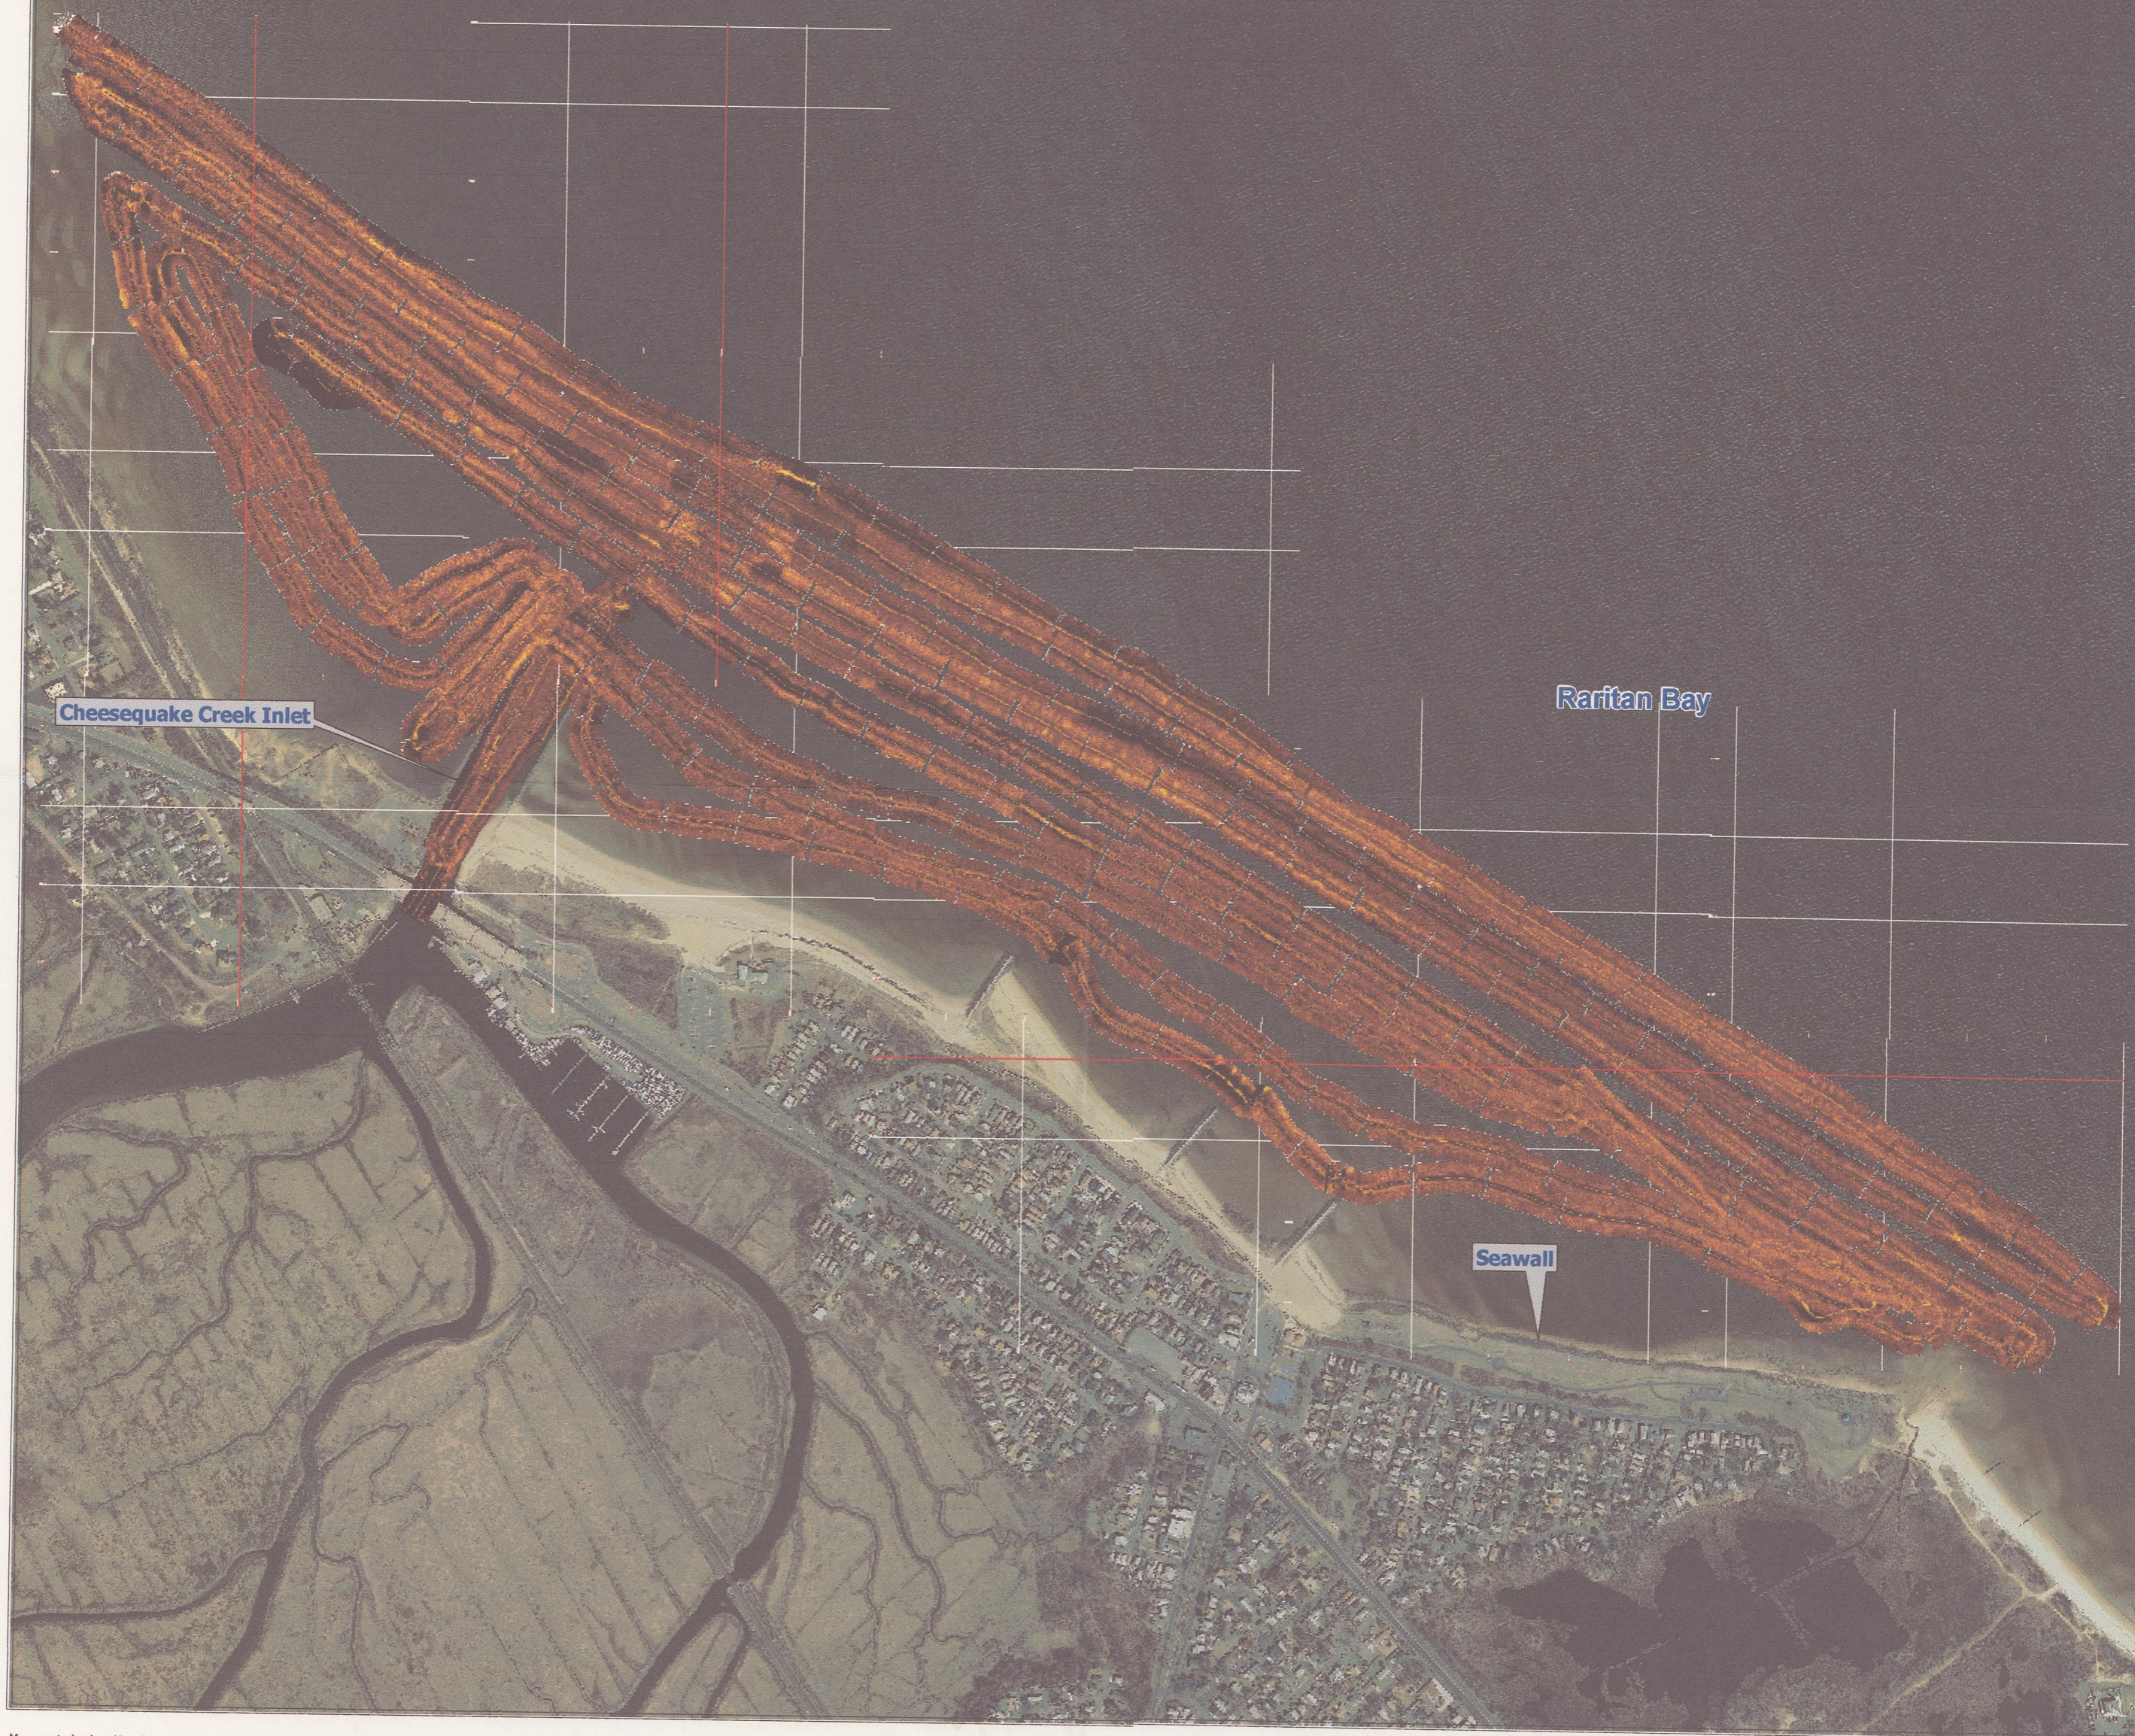
Figure 2
Side Scan Imagery Raritan Bay
Raritan Bay Slag Site
Old Bridge Township, New Jersey
May, 2009

1. The side scan survey covered approximately two miles of coastline extending from the cove area just east of the seawall to approximately 0.5 miles west of the Cheesequake Creek Inlet western jetty. Approximately nine transects were completed along the shoreline to a distance of approximately 1,800 feet into Raritan Bay. The coverage area is detailed in Figure 2. This entire search showed no indication on the sonar record of any items larger than single rocks, fish traps, or discarded tires. No significant rock piles were noted during the side scan survey. To verify the sonar image as well as the GPS data generated by the sonar image, a sunken barge was chosen as a dive location (Figure 3). A GPS point located in the center of the bow was chosen from the sonar image, a buoy was placed at that location, and a diver was deployed to verify the sonar image and location. The diver confirmed the placement of the buoy and the sonar image.

The side scan sonar data from the bay portion of the survey indicates that there is an area showing similar surface features to the inlet side of the eastern jetty just as the inlet empties into Raritan Bay. This area may be a depositional area from the Cheesequake Creek which was not sampled.

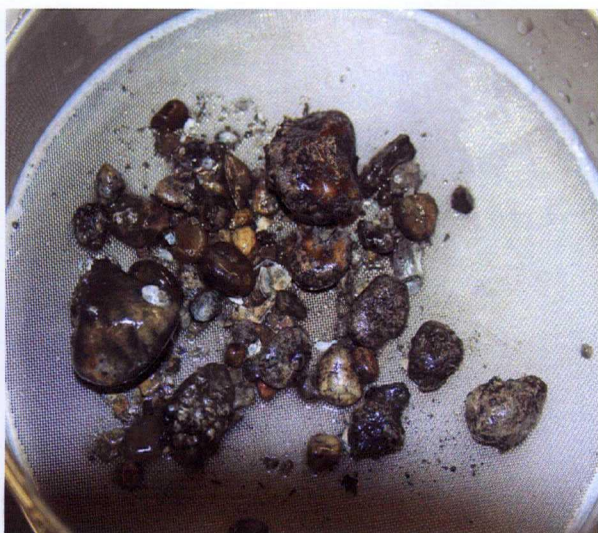
Figure 4: Sample S-1

7. Samples were collected from the Cheesequake Creek Inlet as noted on Figure 1. The composition of each sample is as follows:
 - S-1. No sediment, sample consisted 100% of pebbles and stones. (Figure 4)

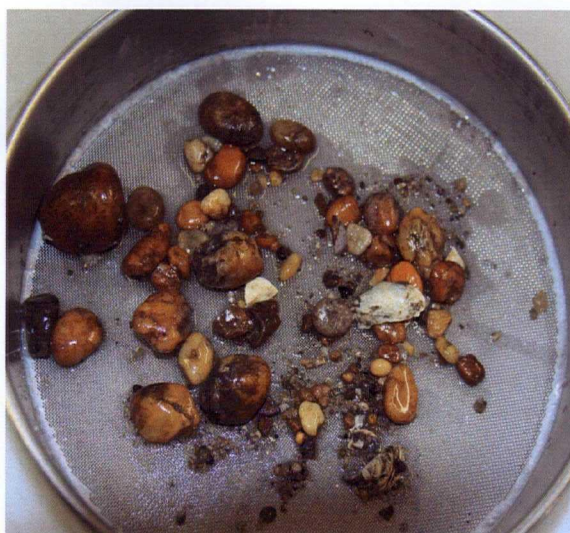
Figure 5: Sample S-3

- S-3. No sediment, sample consisted 100% of pebbles and stones. (Figure 5)
 - S-4. No sediment, sample consisted 100% of pebbles and stones. (Figure 6)

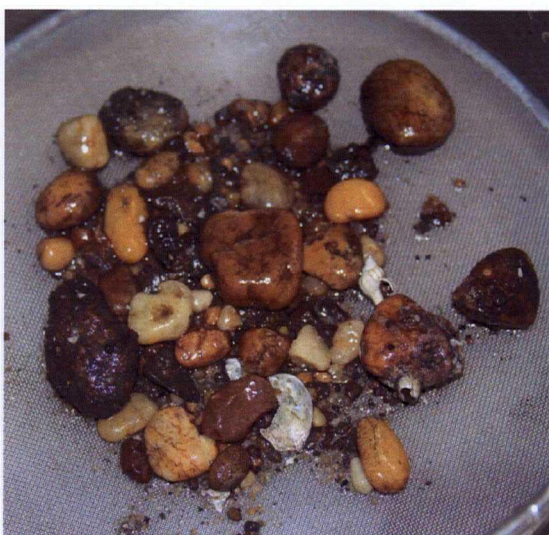
Figure 7: Sample S-6

- S-6. No sediment, sample consisted 100% of pebbles and stones. (Figure 7)
 - S-7. No sediment, sample consisted 95% of pebbles and stones, 5% coarse sand. (Figure 8)

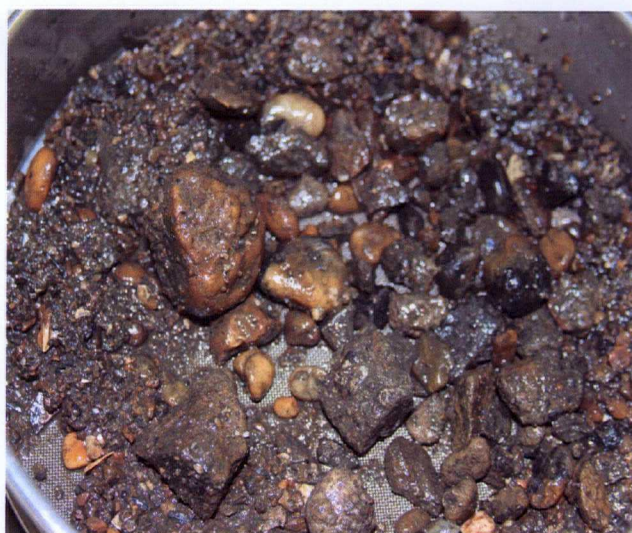
Figure 9: Sample S-9

- S-9. Sample consisted of 85% pebbles, stones and coarse sand, 15% sediment (Figure 9). One 4-ounce jar was submitted for metals analysis.

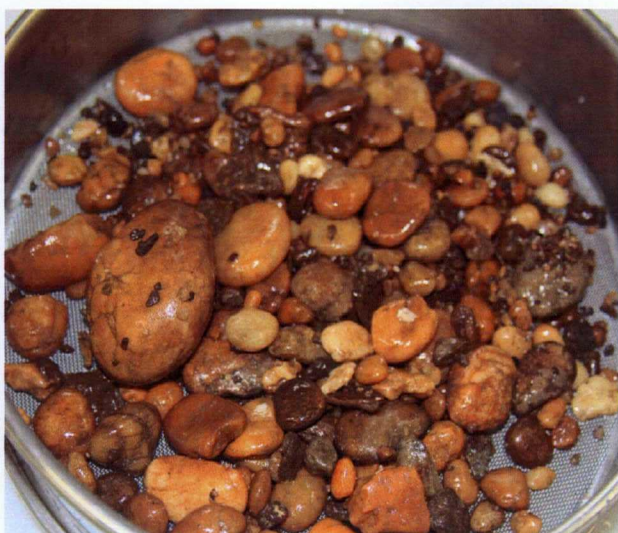
Figure 10: Sample S-10

S-10. No sediment, sample consisted 100% of pebbles and stones. (Figure 10)

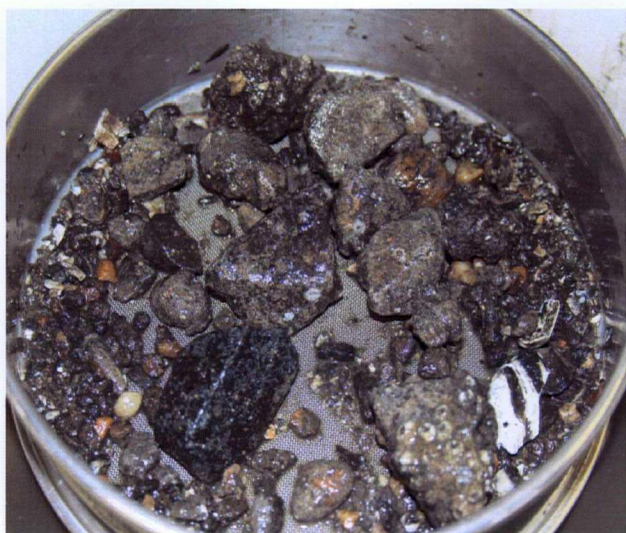
Figure 11: Sample S-13

S-13. Sample consisted of 85% pebbles, stones and coarse sand, 15% sediment (Figure 11). One 4-ounce jar was submitted for metals analysis.

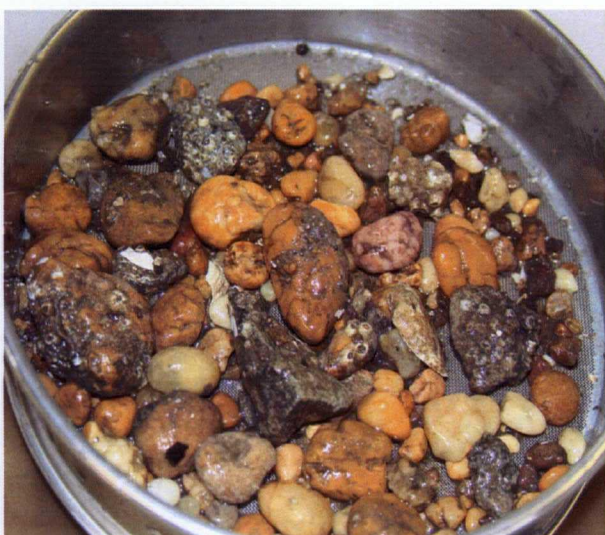
Figure 12: Sample S-14

S-14. Sample consisted of 90% pebbles, stones and coarse sand, 10% sediment (Figure 12). One 4-ounce jar was submitted for metals analysis.

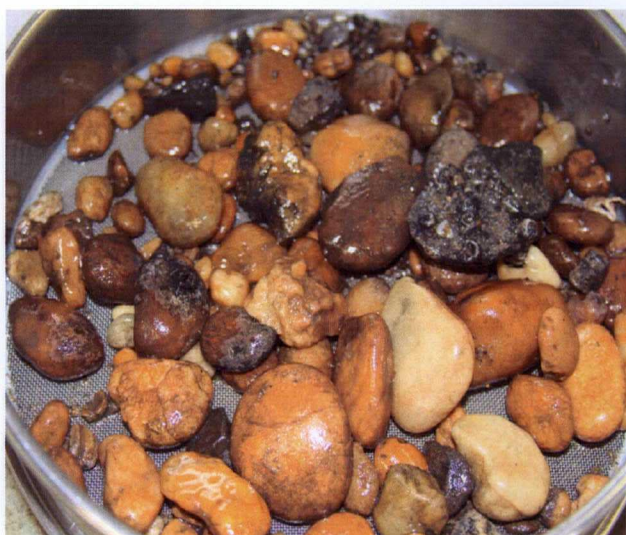
Figure 13: Sample S-15

S-15. No sediment, sample consisted 100% of pebbles and stones. (Figure 13)

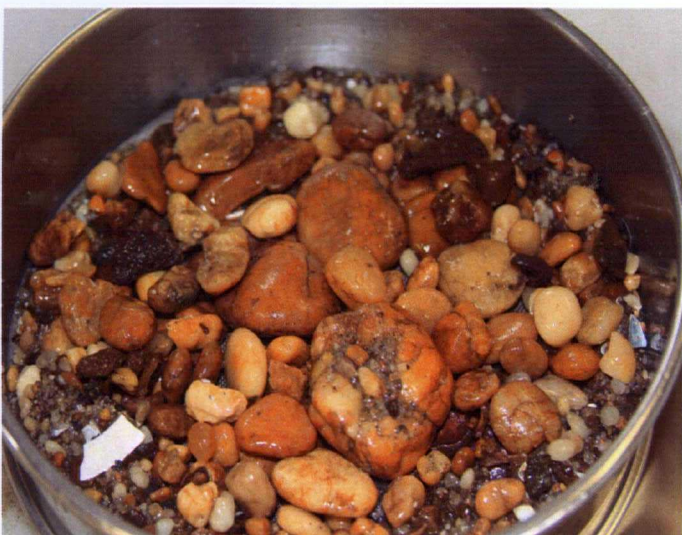
Figure 14: Sample S-16

S-16. Sample consisted of 90% pebbles, stones and coarse sand, 10% sediment (Figure 14). One 4-ounce jar was submitted for metals analysis.
